Active Silicon FireBird (CoaXPress)

DCAM Version

DCAM Module	23.12.4322.6736	(for 64-bit)
DRIVER	8.26.1400.6736	(for 4XCXP6-2PE8)
	8.26.1400.6736	(for 2XCXP6-2PE8)

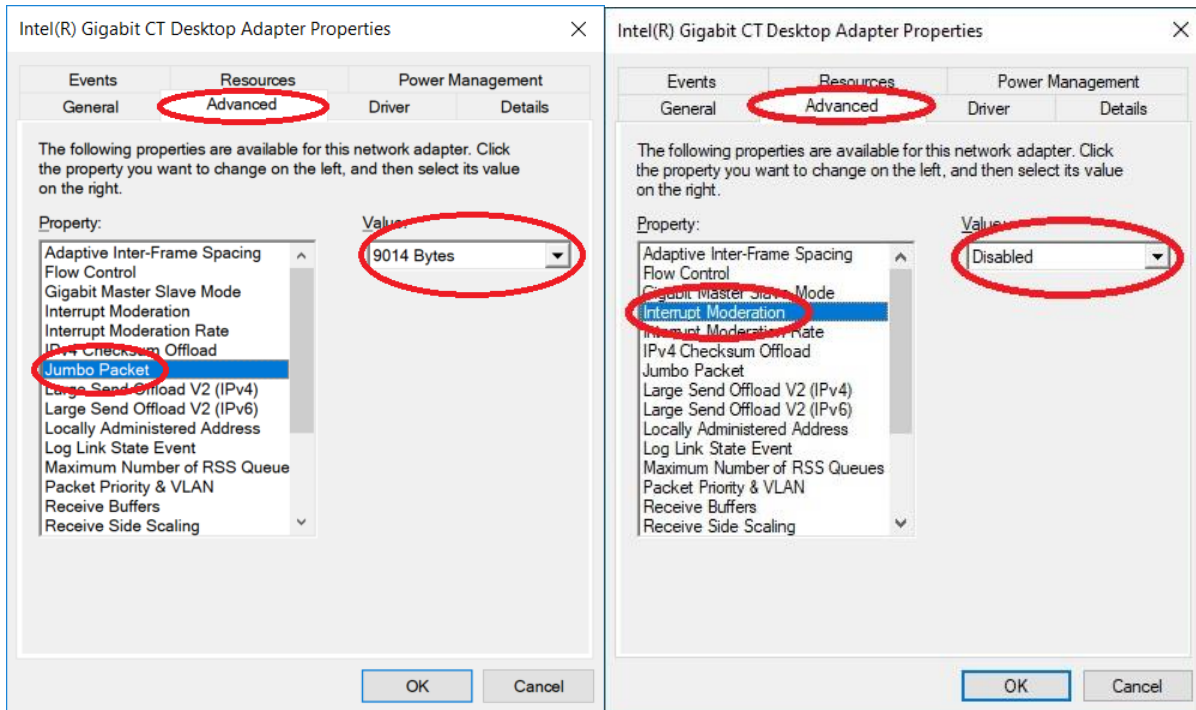
It is highly recommended to tweak these settings for the Gigabit Network Adapter for which the GigE device is connected, provided they are available for adjustment in Device Manager \ Properties for the adapter driver:
