Active Silicon FireBird (CoaXPress)

DCAM Version

DCAM Module 24.10.4322.6873 (for 64-bit)

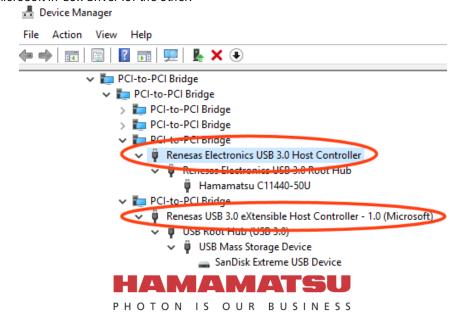
If you install the Renesas driver to Windows 10 or higher, it will change the driver for every Renesas µPD720201/2 controller present in your system during the time of installation. If you have multiple USB 3.0 devices (ex – a C13440-20CU ORCA-Flash4.0 (V3)) in the same system connected to independent Renesas µPD720202 controllers than the hardware mentioned above, that hardware may work with better performance if the Microsoft in-box drivers are used. For those other USB 3.0 devices, you can use Device Manager with View devices by connection, then Update Driver to the Renesas controller connected to the other devices manually to switch those controllers back to the Microsoft in-box driver. Device Manager could then look like this example with the Renesas driver for one controller, and the Microsoft in-box driver for the other:
